**Flood Control Project Maintenance  
Levee Inspections**

**Maintenance Issue Types Only, Levee Inspection Report By Mile - Fall 2018**

**Sacramento Maintenance Yard Sacramento Bypass**

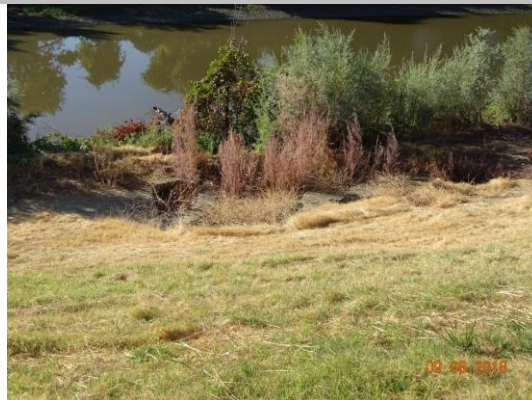
Photo 1 of 1 : FA\_2018\_ST0008\_284\_8\_20180906\_00012.jpg

LM Start	0.60	Rating **	A/W	Issue No.	8
LM End	0.60	Issue Type +	Ma	Location *	WS
Category	Earthen Levee			GPS Latitude/Longitude	
				Start	End
Item	Animal Control			38.603983 °	38.603983 °
				-121.570268 °	-121.570268 °
DWR ID	DWR_ST0008_01_f_2018_8				
Comment Code					
A1 : Exterminate rodents and backfill and compact or grout burrows.					
Inspector Comment					
Beaver den on waterside toe road. Sac Yard will fill within the next few months.

View of beaver den on the waterside toe road. Fall 2018.

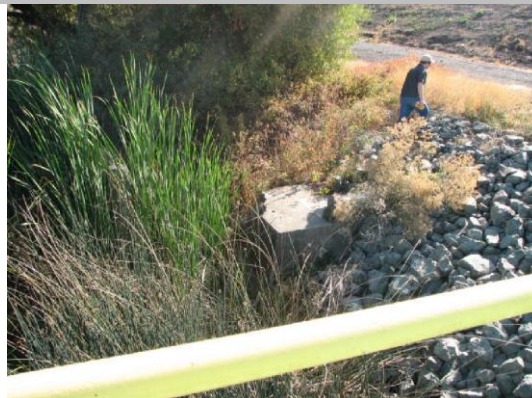
Photo 1 of 3 : UCIP\_FA\_2018\_44787\_20605.jpg

LM Start	1.09	Rating **	A/W	Issue No.	16	
LM End	1.09	Issue Type +	Ma	Location *		
Category	Supplemental			GPS Latitude/Longitude		
				Start		End
Item	DWR UCIP LMA Responsibility			38.602169 °		38.602169 °
				-121.579000 °		-121.579000 °
DWR ID	19076					
Comment Code						
Inspector Comment						
FS_ID:44787						
DS_ID:19076						
EP_NO: N/A						
Repair Type: No Action Needed						
Crossing Status: Found						
UCIP Comments: A concrete saddle found on slough/drainage. No pump was found on LS and no structure/pipe found on WS.						
FIELD_STRUCT_DESC: *ABANDONED* 36-inch corrugated metal drainage pipe through the levee, at an unknown depth. Grouted in place. Remains of concrete structure found on the landside (LS).						
[Additional Reference(s): USACE Sacramento O&M Manual 122.1, August 1955, (RM 174)].						
FS Date: 4/28/2015 2:44:05 PM

Landside view: overview

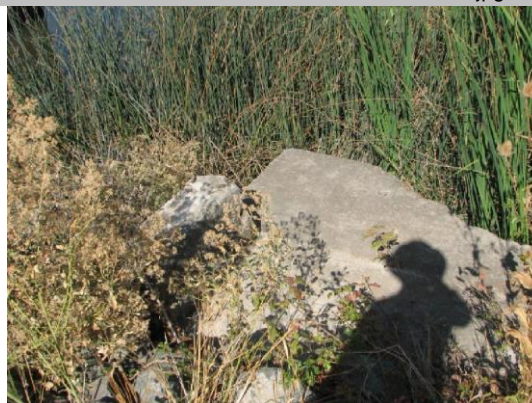
Photo 2 of 3 : UCIP\_FA\_2018\_44787\_20604.jpg

Landside view: remaining of concrete structure

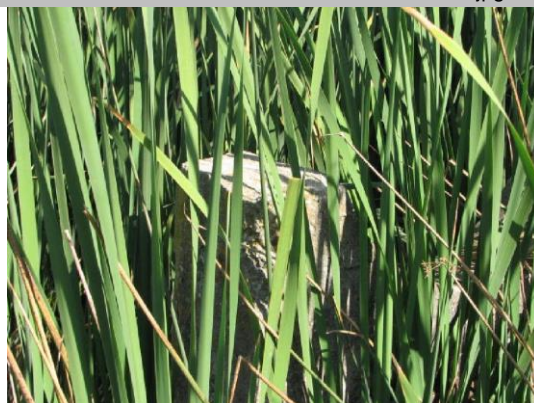
Photo 3 of 3 : UCIP\_FA\_2018\_44787\_20606.jpg

Landside view: remaining of concrete structure on drainage/slough

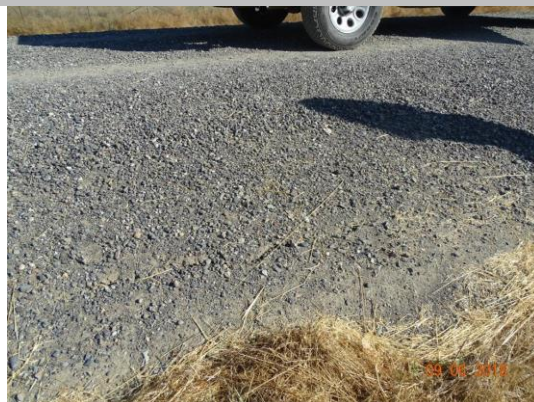
Photo 1 of 1 : FA\_2018\_ST0008\_284\_7\_20180924\_00013.jpg

LM Start	1.43	Rating **	A/W	Issue No.	7
LM End	1.59	Issue Type +	Ma	Location *	WS
Category	Supplemental			GPS Latitude/Longitude	
				Start	End
Item	2017 USACE Erosion Survey, DRAFT			38.600456 °	38.599713 °
				-121.584883 °	-121.587668 °
DWR ID	DWR_ST0008_01_f_2018_7				
Comment Code					
Inspector Comment					
2017 Site ID: SAP 1.4 R					
Status: Critical					
2017 Field Notes: New site, immediately upgraded to critical. Start of slump failure, deep cracks along levee crest, concern that a large slump failure will occur from the next heavy rain.					
Site History:					
DWR Inspector Comment: Did not observe significant damage on the waterside slope. Minor cracking on the crown. Recommend monitoring.

View of the cracking on the crown. Fall 2018.

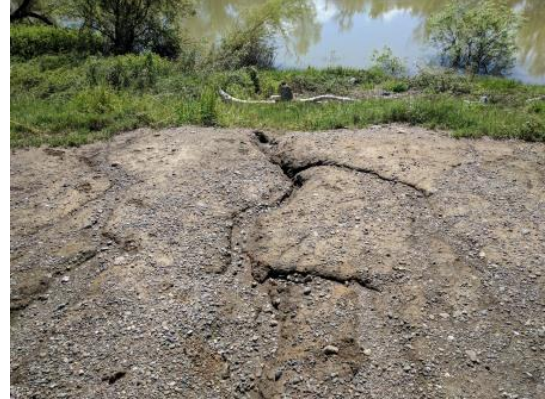
Photo 1 of 1 : FA\_2018\_ST0008\_284\_15\_20180904\_00002.jpg

LM Start	1.74	Rating **	A/W	Issue No.	15
LM End	1.74	Issue Type +	Ma	Location *	WS
Category	Earthen Levee			GPS Latitude/Longitude	
				Start	End
Item	Erosion / Bank Caving			38.599546 °	38.599546 °
				-121.590235 °	-121.590235 °
DWR ID	DWR_ST0008_01_s_2018_15				
Comment Code					
E1 : Note and monitor erosion site.					
Inspector Comment					
Runoff erosion on oversized levee section. Lcoated on waterside levee slope. Recommend monitoring.

View of erosion on waterside slope. Spring 2017.

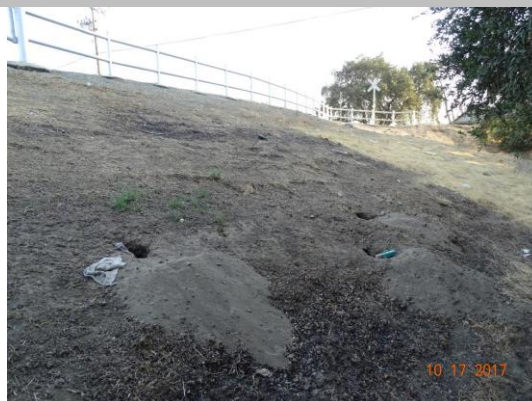
Photo 1 of 2 : FA\_2018\_ST0008\_285\_2\_20180904\_00004.jpg

LM Start	0.03	Rating **	M	Issue No.	2
LM End	0.03	Issue Type +	Ma	Location *	LS
Category	Earthen Levee			GPS Latitude/Longitude	
				Start	End
Item	Animal Control			38.602613 °	38.602613 °
				-121.556021 °	-121.556021 °
DWR ID	DWR_ST0008_02_s_2016_2				
Comment Code					
A3 : No rodents visible, but rodent burrows visible; need to backfill and compact or grout burrows.					
Inspector Comment

Updated view of rodent holes on landside slope. Fall 2017.

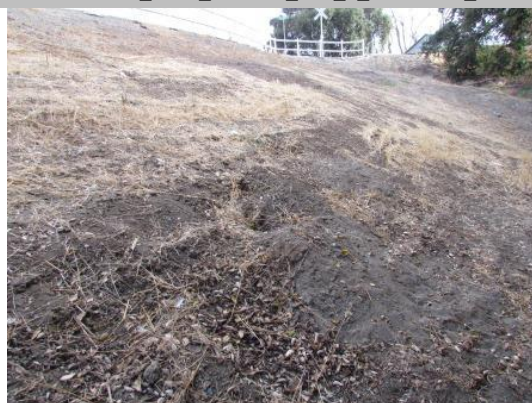
Photo 2 of 2 : FA\_2018\_ST0008\_285\_2\_20180904\_00005.jpg

View of rodent holes on LS slope of the levee near entry gate. Fall 2016..

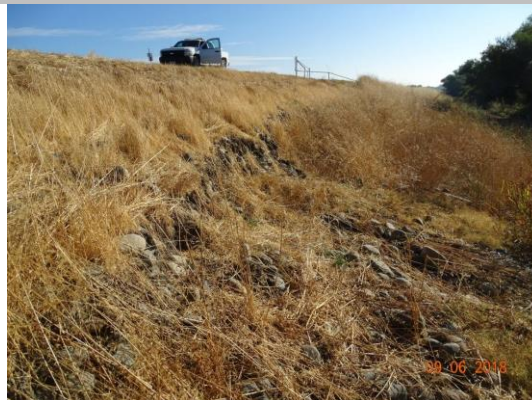
Photo 1 of 4 : FA\_2018\_ST0008\_285\_1\_20180906\_00009.jpg

Notes: Minor wavewash on landside levee slope; no active erosion; no cross section taken, photo only. The erosion is not within the prism. Sac Yard will fix after vegetation gets burned. Fall 2018.

View of the worst section of erosion, just past the gate near the end of the unit. Fall 2018.

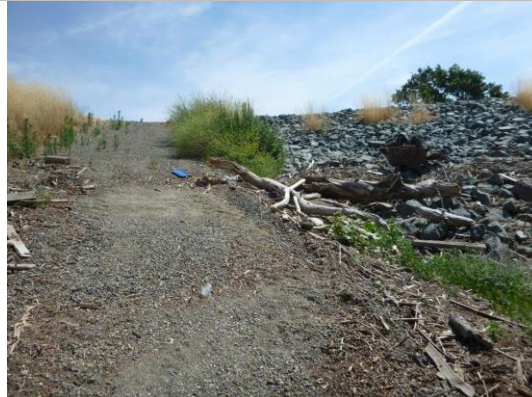
Photo 2 of 4 : LEVAL\_FA\_2018\_260\_471.jpg

Photo from storm site evaluations.

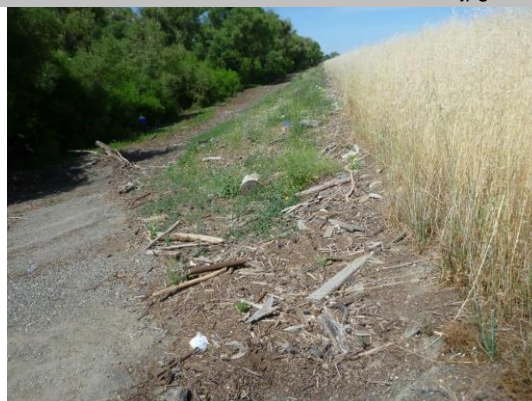
Photo 3 of 4 : LEVAL\_FA\_2018\_260\_473.jpg

Notes: Minor wavewash on landside levee slope; no active erosion; no cross section taken, photo only. The erosion is not within the prism. Sac Yard will fix after vegetation gets burned. Fall 2018.

Photo from storm site evaluations.

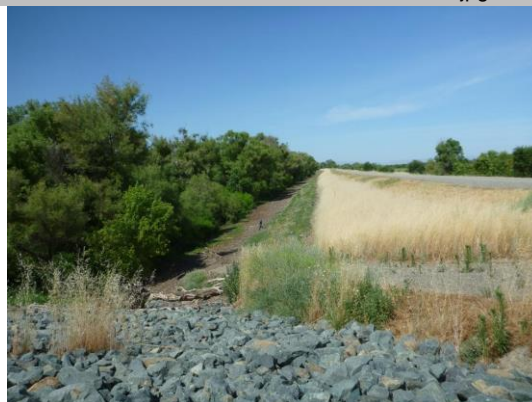
Photo 4 of 4 : LEVAL\_FA\_2018\_260\_475.jpg

Photo from storm site evaluations.

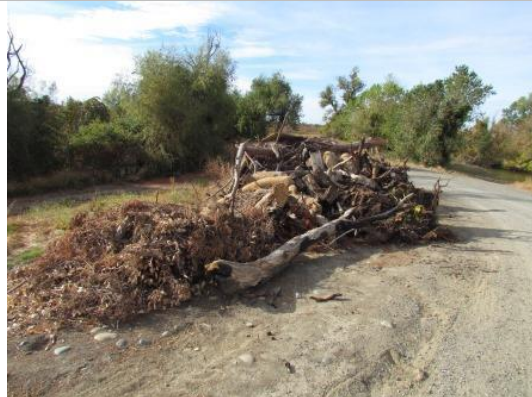
Photo 1 of 2 : FA\_2018\_ST0008\_285\_5\_20180904\_00006.jpg

LM Start	1.77	Rating **	A/W	Issue No.	5
LM End	1.77	Issue Type +	Ma	Location *	LS
Category	Earthen Levee			GPS Latitude/Longitude	
				Start	End
Item	Encroachments			38.594743 °	38.594743 °
				-121.586556 °	-121.586556 °
DWR ID	DWR_ST0008_02_s_2016_5				
Comment Code					
PR : Prunings					
Inspector Comment					
This is a seasonal pile but gets burned by the LMA each year.

Burn Pile. Fall 2016.

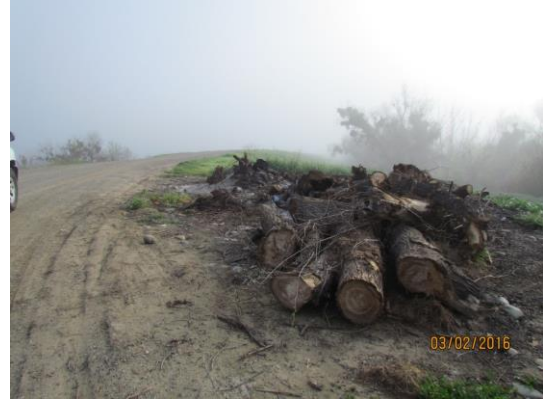
Photo 2 of 2 : FA\_2018\_ST0008\_285\_5\_20180904\_00007.jpg

LM Start	1.77	Rating **	A/W	Issue No.	5 (cont)	
LM End	1.77	Issue Type +	Ma	Location *	LS	
Category	Earthen Levee			GPS Latitude/Longitude		
				Start		End
Item	Encroachments			38.594743 °		38.594743 °
				-121.586556 °		-121.586556 °
DWR ID	DWR_ST0008_02_s_2016_5					
Comment Code						
PR : Prunings						
Inspector Comment						
This is a seasonal pile but gets burned by the LMA each year.

View of the firewood on the landward side of the levee looking upstream. Spring 2016.

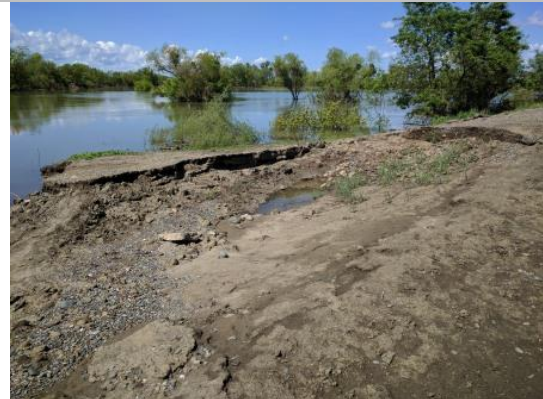
Photo 1 of 1 : FA\_2018\_ST0008\_285\_8\_20180904\_00008.jpg

LM Start	1.77	Rating **	A/W	Issue No.	8
LM End	1.77	Issue Type +	Ma	Location *	WS
Category	Earthen Levee			GPS Latitude/Longitude	
				Start	End
Item	Erosion / Bank Caving			38.594710 °	38.594710 °
				-121.586582 °	-121.586582 °
DWR ID	DWR_ST0008_02_s_2017_8				
Comment Code					
E1 : Note and monitor erosion site.					
Inspector Comment					
Runoff location, but not within the levee prism. Recommend monitoring.

View of erosion on waterside levee slope. Spring 2017.
